DEPARTMENT OF TRANSPORTATION

Quality Assurance and Source Inspection

WELDING INSPECTION REPORT

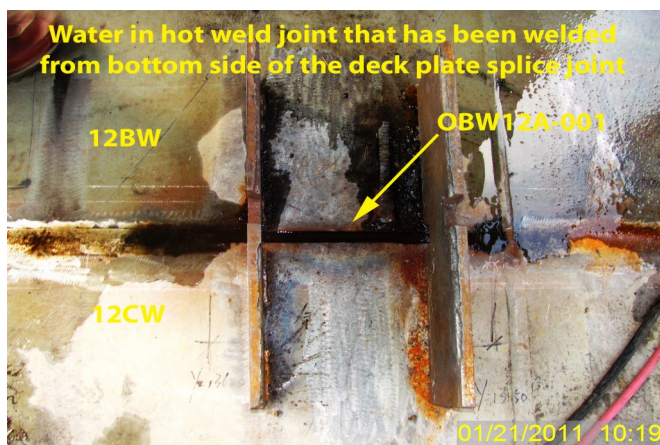
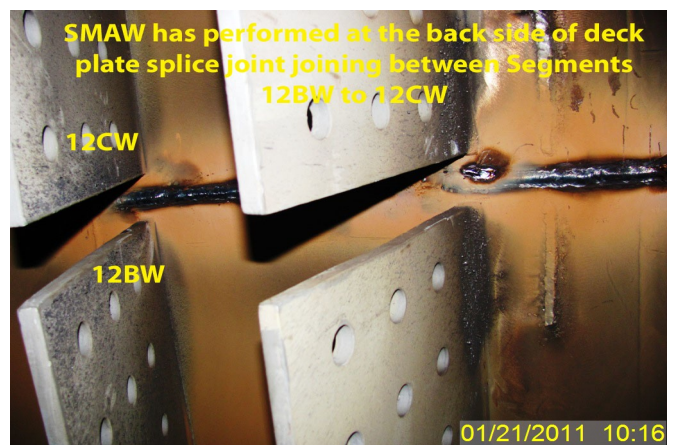
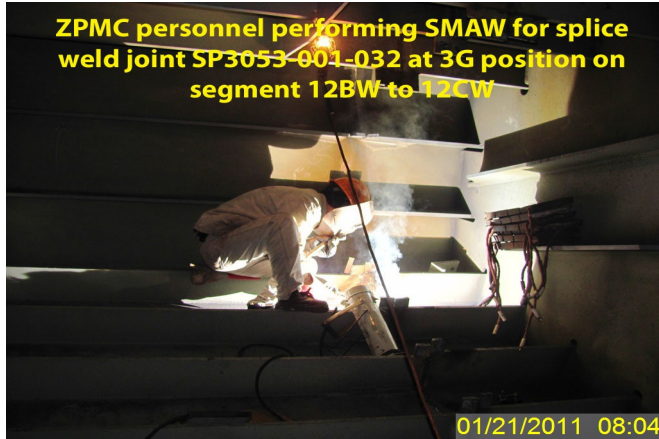
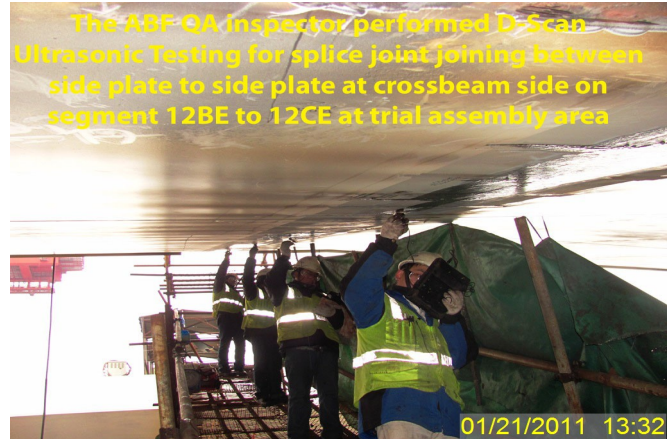
SMAW in the 3G position for the OBG Segment 12BW to 12CW weld No.SP3053-001-032. The welder is identified as #046709. ZPMC QC is identified as Mr.Shi Lei. The welding variables recorded by QC appear to comply with WPS-B-P-2213-B-U2-FCM-1.

SMAW in the 3G position for the OBG Segment 12BW to 12CW weld No.SP3050-001-038. The welder is identified as #046704. ZPMC QC is identified as Mr.Shi Lei. The welding variables recorded by QC appear to comply with WPS-B-P-2213-B-U2-FCM-1.

SMAW in the 3G position for the OBG Segment 12BW to 12CW weld No.SP3038-001-031. The welder is identified as #046709. ZPMC QC is identified as Mr.Shi Lei. The welding variables recorded by QC appear to comply with WPS-B-P-2213-B-U2-FCM-1.

During random in-process visual inspection of welds located on Orthotropic Box Girder (OBG) segment 12BW and 12CW, this Quality Assurance Inspector (QA) discovered the following issues that ZPMC personnel performed Shielded Metal Arc Welding (SMAW) on the inside of deck plate splice joining Segments 12BW to 12CW while standing water was on the top/outside of deck plate. The weld is identified as OBW12A-001. The Weld is Complete Joint Penetration (CJP) butt joint. The Weld is non Seismic Performance Critical Members (non SPCM). The Y distance for the exposed area was 13150 mm to 13620mm as measured from counter weight side, edge plate along the deck plate splice. The segments are located at trial assembly area.

This QA generated an incident report on this date.
